Lessons in slope stability management from Kinross' Tasiast mine, Mauritania

Korhan Tasoren ^{a, *}, Gillian Gardhouse, P.Eng. ^b, Dr. Jerry Ran, P.Eng. ^c

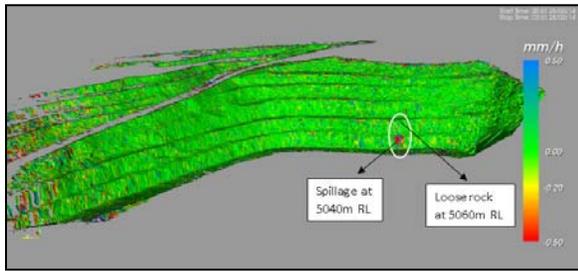
A loose rock fell 50 m from a bench crest to the pit floor on the hanging wall side of the Piment Central Pit during a night shift. The slope monitoring radar was able to detect the movement, which was caused by crest damage, but was unable to send an alarm to the site geotechnical team because the movement was sudden rather than progressive (Figure 4). The radar data indicated that the loose rock had a mean displacement of 1.10 mm and a velocity of 2.5 mm/h (Figure 5).

Figure 4: Slope monitoring system screen shot of the movement area during the event.

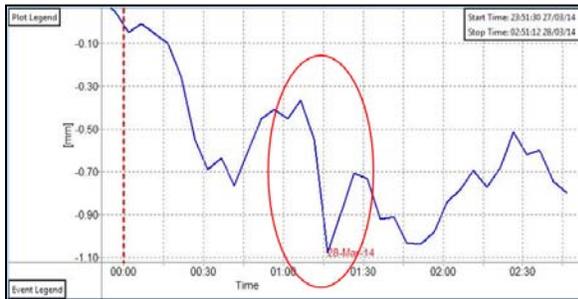
Figure 5: Displacement graph of the event.

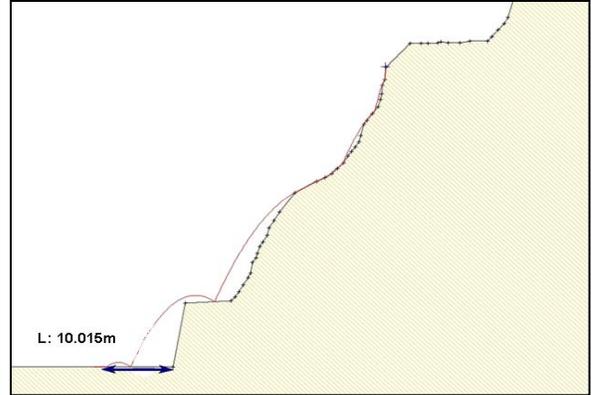
RocFall software (Rocscience) was used to back analyze the rockfall event and calculate the displacement. The weight of the rock mass was estimated to be 200 kg. A face profile was created using AdamTech photogrammetry software. The actual distance from the toe at the pit bottom to the final resting location of the spilled rock was measured at 10.75 m in the field and calculated at 10.015 m by the RocFall model, demonstrating that the model is an adequate representation of the event (Figure 6).

Figure 6: Back analysis of the rockfall incident using RocFall software.

The root cause of the failure was the presence of loose rocks on the broken crest due to blasting damage, excessive sub-drilling, and poor face clean-up practices. The geological characteristics of the region adjacent to the blast and further up the slope dictate the potential for blast-induced damage (Read & Stacey, 2008). The hazard area was identified, a high windrow was built along the ramp 10 m away from the toe, and a 15 m standoff distance procedure was put in place for the rest of the pit to prevent similar incidents. A 20 m vertical mid-bench presplit blasting design was applied to the pit hanging wall to reduce production blast damage to the face, since a proper trim blast could not be implemented in such a narrow and small scale mining environment. Significant improvements have been observed in the condition of the face and in pit design compliance since implementing the pre-split design (Figure 7).

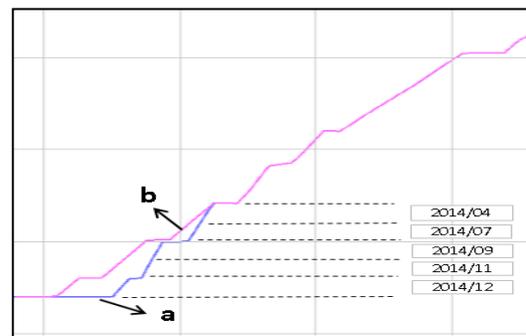
Figure 7: a) Actual pit wall design after implementing pre-splitting procedures; b) Predicted pit wall without wall control blasting.

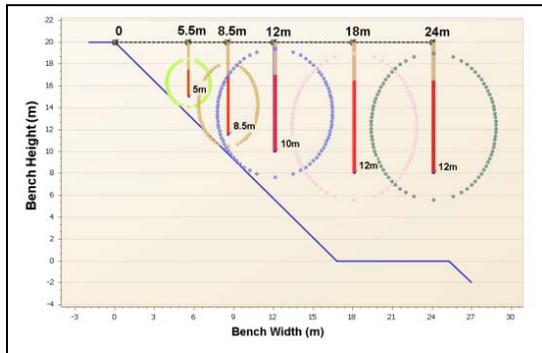
strikes 350° and has an average spacing of 2.5 m. Previous blast designs used in the early stage of the project did not consider these design limitations, which led to excessive damage in the oxide and transition zones on the footwall. This was exacerbated by the use of standard full depth vertical blast holes near the wall.

Several small, bench scale planar failures were experienced as a result of damaged or narrow catch berms, and broken toes. The typical failure dimension was limited to 20 m long by 2 m wide by 30 m high due to the condition of the rockmass and the intersection of joint sets.

Figure 8: An example of a modified footwall trim blast design.

To prevent blast damage, a modified trim blast design was applied to the area near the footwall (Figure 8). Two stepped holes were introduced to break the rock along the foliation surface and achieve the pit design. This approach resulted in smooth face conditions along the foliation plane and improved pit design compliance on the footwall.

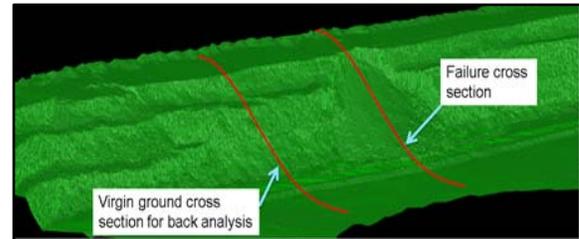
The Turek 2 pit is one of the oxide satellite pits that will eventually become part of the West Branch pit as mining progresses. The Turek 2 pit has 10 m high benches with 6.5 m wide catch berms and a 65° BFA. It is 45 m deep. Approximately 400 tons of material fell several benches to the bottom of the pit, resulting in a failure area 25 m long, 3 m deep and 25 m high. A 75° foliation angle was measured on the pit face where the failure occurred.

Back break was observed on the catch berm parallel to the strike of the foliation after production blasting. No consideration for wall control had been included in the blast design, such that a high energy charge was used in soft rock, causing damage to the final wall. Rainfall flow marks were found on the top of the pit in the failure area during the incident investigation. Over-digging was observed on the face, resulting in a very narrow catch bench berm. Together these factors contributed to the failure.

Figure 9: Photogrammetric surface of the failure area.

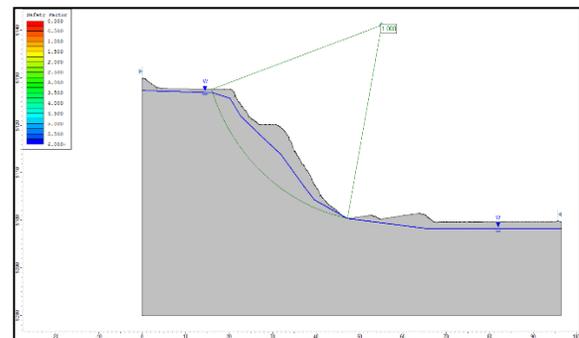
SLIDE v5.0 software (Rocscience) was used to back analyze the failure. Inputs included a high resolution photogrammetry face profile (Figure 9), steep transient water table profile behind the face, and density, cohesion, and friction angle values. Different combinations of the input parameters shown in Table 2 were analyzed to simulate conditions similar to those of the failure. The SLIDE v.5.0 results are shown in Figure 10. All of the condition combinations suggest a Factor of Safety (FOS) of 1.0 (Table 3).

Figure 10: SLIDE v5.0 section of the hanging wall.

The following rockmass characteristics were determined as a result of the back analysis: the cohesion is 19 kPa, the friction angle is 30° and the unit weight is 25 kN/m³ for similar types of material. The effect of weathering in the oxide zone was greater in the hanging wall of the Turek 2 pit than in the West Branch area. Based on this, the Turek 2 pit geometry was modified to 10 m high benches with 7 m wide catch berms and a 55° bench face angle.

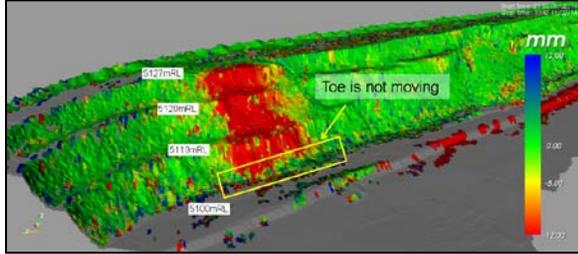
The pit design was reviewed and modified after the failure. A 15 m wide catch berm was left on the hanging wall, and a radar system was set-up to detect any further movement. A similar type of movement was observed by the slope monitoring system on the northern side of the failure (Figure 11). Blasted

Figure 11: Movement at the northern side of the failure.

material was left as a buttress to prevent excessive movement along the face. Only a toe charge was applied to the first row of the production blast to further reduce vibrations and related damage.
