## Rockburst mitigation experiences on underground projects in the Cheves Hydropower project in the Peruvian Andes

### ABSTRACT

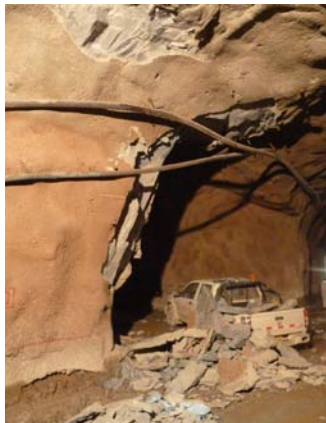
Figures 3 and 4 show an example of two rockbursts that happened in Cheves project, the first one behind the excavation face, near the Powerhouse cavern, and the second one at the excavation face during the construction of the Headrace tunnel.

Figure 3: Rockburst in a drift near the Powerhouse Complex.

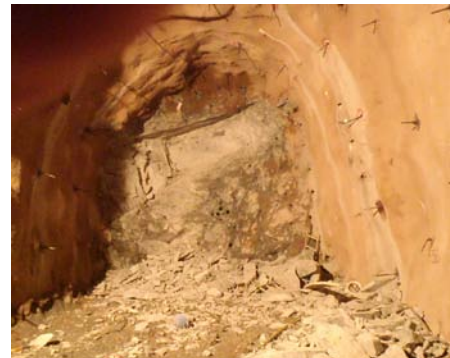
Figure 4: Rockburst at the face excavation in the headrace tunnel.

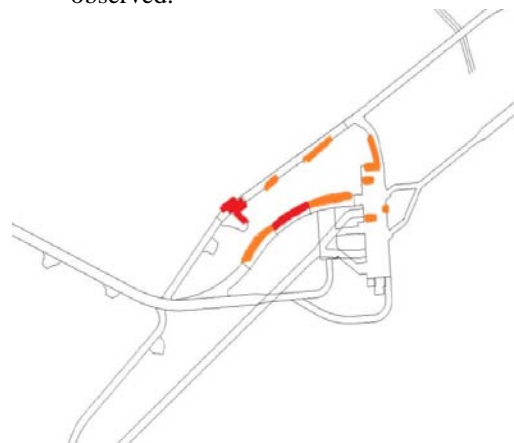
- Induced stresses:** the excavation of multiple faces at the same time, as well as the existence of close excavations played a key role in the probability of rockburst events. This issue had a significant impact on the powerhouse area due to the great number of close drifts, as can be observed in Figure 6, in which the rockburst events are highlighted in orange (medium intensity) and red (high intensity).

Figure 6: Rockbursts record in the Powerhouse area.

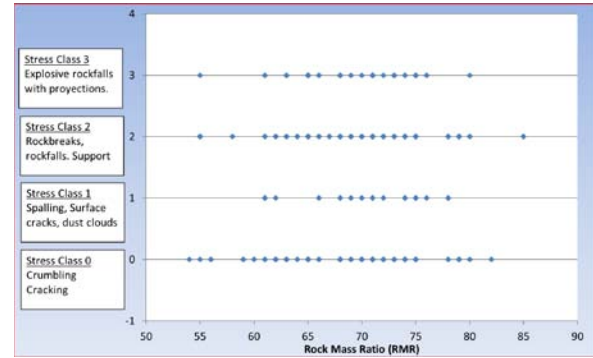
The rock mass rating (RMR) and the rockburst intensity are analyzed in Figure 8. Most of the severe events (stress class 3) belong to rock class II and I, i.e. when the RMR is higher than 61.

Figure 8: Rockburst intensity vs. RMR index.

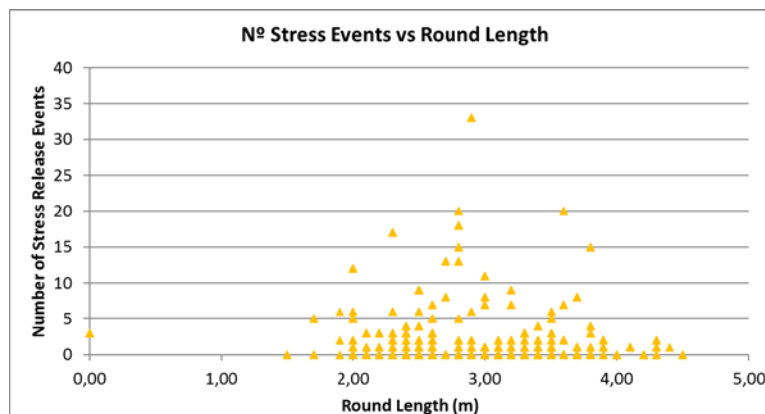
Finally, the relation between the blasting length and the number of events is analyzed in Figure 10. It's worth mentioning an increase in the number of rockbursts in parallel to the increase of the blasting length. It can be observed that there is no clear relation between rockburst occurrence and the blasting length.

Figure 10: Blasting length vs. number of events.
