Rockburst experiences in Cheves Hydropower Project, Perú

Cheves Hydropower Project is located in Peru and consists in approximately 20 km of tunnels and two caverns. Most of the Headrace tunnel has been excavated in igneous and metamorphic rocks with high overburden. A high number of stress release events took place during the excavation of the tunnels and caverns. The intensity of these events varies from acoustic emission to a violent rockburst. The paper describes the methodology developed to mitigate the rockburst hazard.

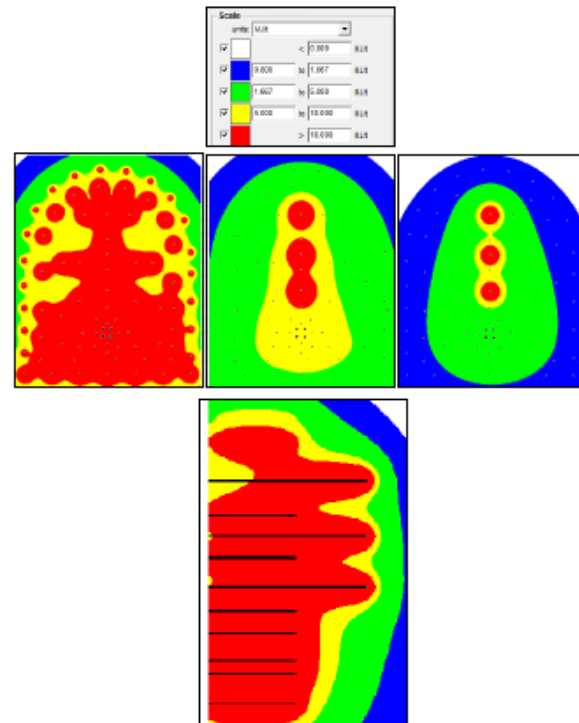
Figure 5: Energy distribution of preconditioning blast with a 3-hole configuration at 51 mm with Slurrex.

Figure 5 below shows the energy distribution at -2.2 m (top left), -3 m (top centre) and -4 m (top right) with a 3-hole configuration at 51 mm with Slurrex.

Analysing the energy distribution, we can predict that energy from production holes interacts with preconditioning holes. These combinations of energies are expected to create a tunnel free face with a set of cracks concentrated vertically. After a first test shot it must be evaluated how those perform. Proper performance implies both a continuous set of vertical cracks interconnected and a good enough rock mass to be drilled around pre-conditioning holes.

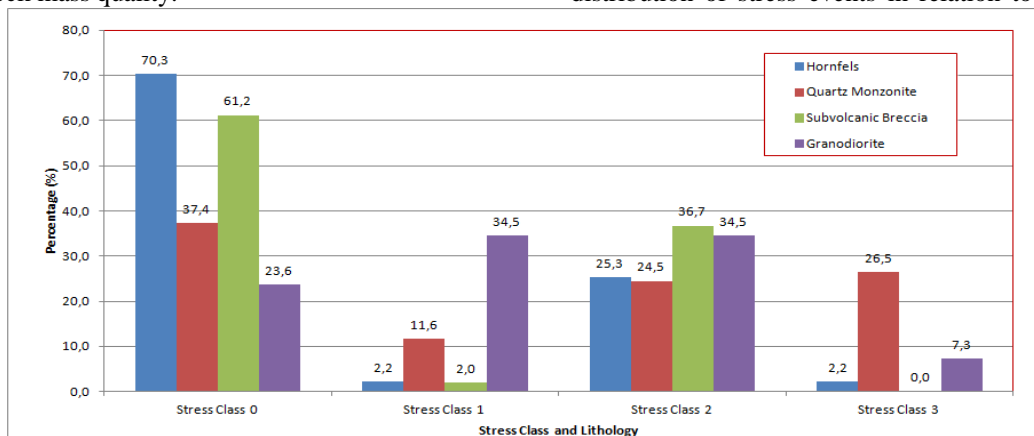
Figure 11: Stress Events vs. Lithology.

A statistical analysis of the results clearly shows that lithology with higher brittle behaviour had suffered a higher number of stress events. It has also been checked that not only areas with good rock conditions are affected by overstress, but also zones where rock mass quality in terms of RMR values are considered fair ground. Figure 11 shows the distribution of stress events in relation to lithology.

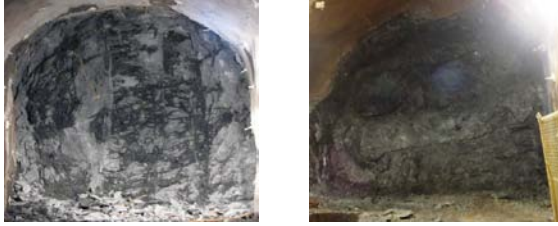
Figure 14: Tunnel face at rockburst events in Headrace tunnel.

It was also detected that when shear zones associated to the joints system were encountered at the face, the stress events usually turned out. This fact was also detected in the core drillings carried out at the tunnel face. This is clear in the photos shown in Figure 14.

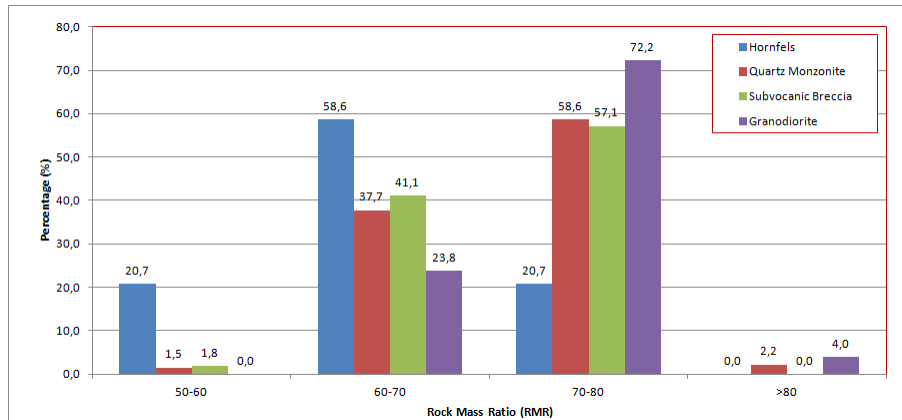
Figure 15: Rock Mass rating (RMR) vs. Lithology.

The rock has been described according the Rock Mass Rating. In all cases the RMR represents a good quality rock mass. Figure 15 shows the relation between the stress events and the RMR value.

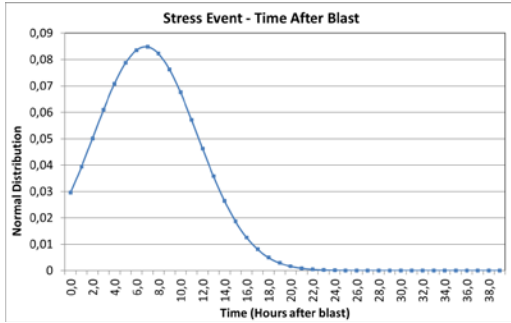
Figure 17: Normal distribution of the Stress Event time after blast. (Theoretical curve).

projects or in mining activities. Figure 17 shows the distribution of the stress events in relation with time after blasting.

Both analyses show that the time event occurrence after blast presents a broad range that makes difficult to define a re-entry strategy.

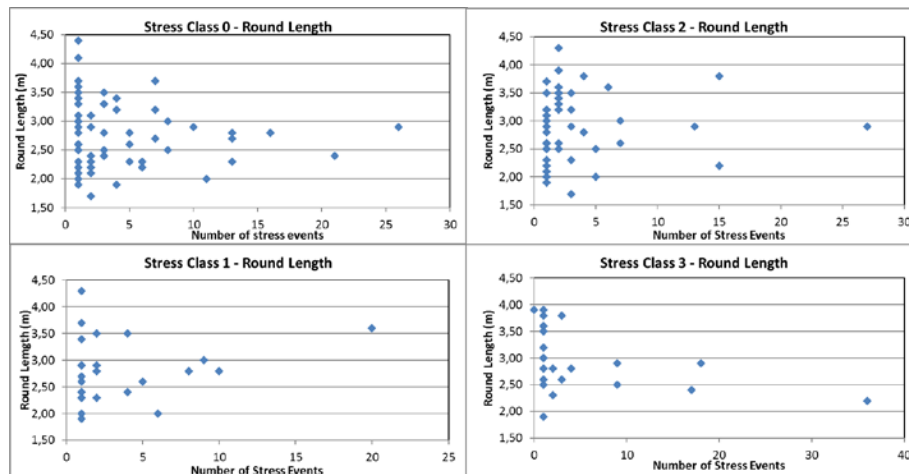
Figure 20(a)-20(d): Number of stress events per each stress class vs. round length.

The distribution of events according to stress classes established by CCH and in relation with the round length has been analyzed. The Figures 20(a)-(d) represent these analyses. The charts clearly show that stress releases are more likely in longer rounds, from 2.5 to 3.5 m.
